Installation and Initial Performance of 60" ADS N-12HC[®] HDPE Pipes

RI 01-037

June, 2002

**INSTALLATION AND INITIAL PERFORMANCE
OF 60" ADS N-12HC[®] HDPE PIPES**

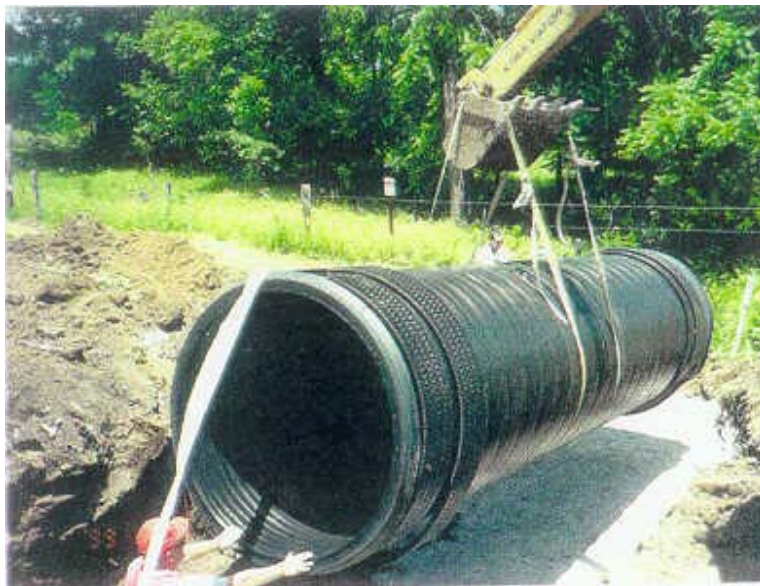
Figure 4. Laying Down Pipe 1

The pipe was laid to grade with bell holes dug at each bell. The joints were assembled by laying the downstream pipe and lowering the upstream pipe with a backhoe, aligning the upstream pipe as it was lowered in place (see Figure 4 and Figure 5). The joints were lubricated prior to installation and pulled together with the backhoe. After all sections of pipe were laid, a chain and come-along were used to pull the joints tight. A visual inspection of the joints showed the maximum opening of any of the joints was approximately 1/2".
